# FUNCTIONAL and Esthetic

# Challenges

## Replacing a Single Anterior Tooth with an Implant

Amanda N. Seay, DDS  
Brad Patrick, BSc

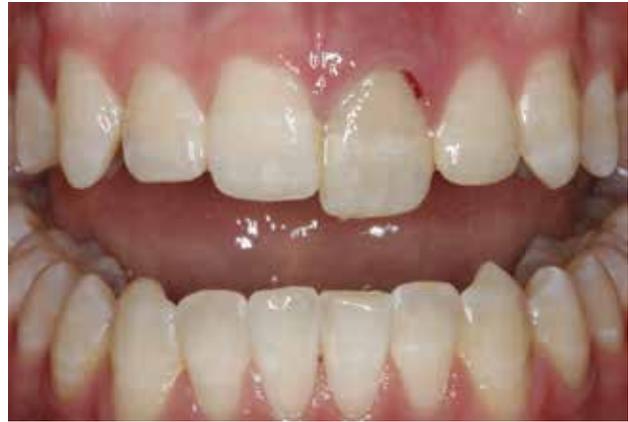
Figure 1: Tooth #9 avulsed after a swimming pool accident.

A 17-year-old male in good health presented with a complete mid-root fracture on tooth #9, the result of a swimming accident. The coronal half of the tooth was mobile and the patient was in considerable discomfort (Fig 1). The patient was seen immediately after the accident and swelling was minimal. A periapical radiograph was taken to further assess the degree of trauma and evaluate the bone on adjacent teeth (Fig 2). Review of the radiograph aided in assessment of any potential esthetic shortcomings, assuming atraumatic extraction of #9. The patient was promptly sent to the surgeon's office to have #9 extracted and, if conditions were determined favorable, for placement of an immediate implant (3i, Biomet; Warsaw, IN) (Fig 3). The patient returned immediately to the restorative dentist for fabrication and placement of a provisional restoration. It would be desirable to, at the very least, give the surgeon an understanding of final restorative tooth position and deliver all necessary models and stents to accomplish this task. However, due to malposition of #9 from the accident, the surgeon was asked to mirror the coronal tooth position of #8 in determining the final position for #9 as bone heights and tissue contours surrounding #8 were all esthetically desirable.<sup>1</sup>

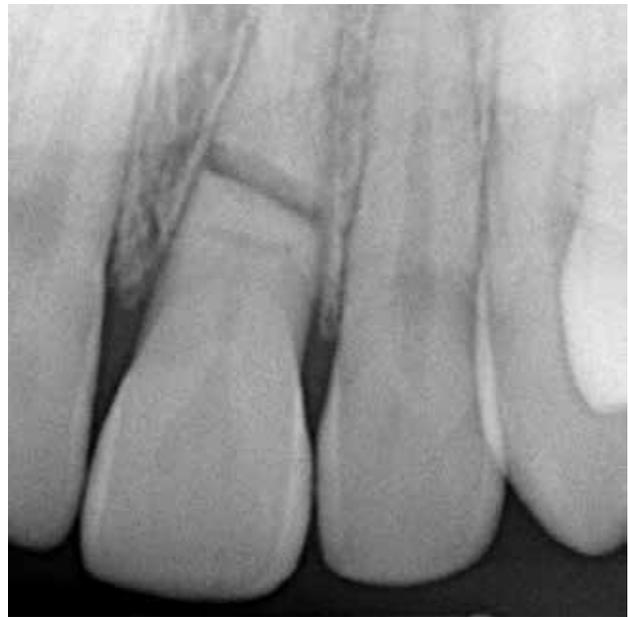
Figure 2: Complete mid-root fracture on #9.

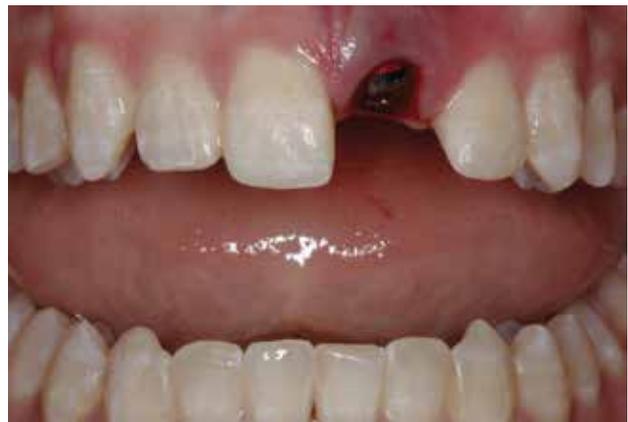
Figure 3: Immediate implant placed.

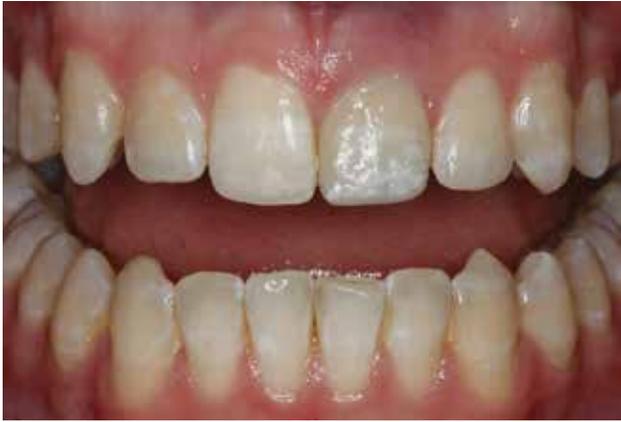
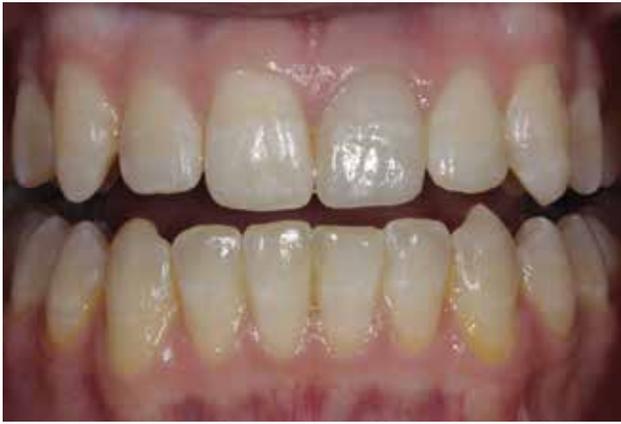
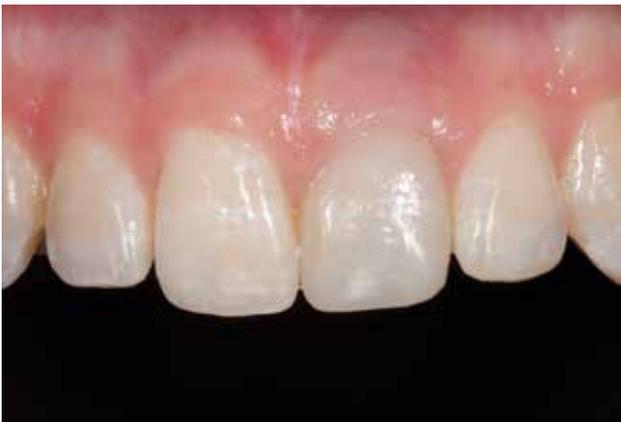
**Figure 4:** Provisional #9, one week postoperative.

**Figure 5:** Provisional, one month postoperative.

**Figure 6:** Provisional, four months postoperative (1:1 view).

In this case, only the putty matrix technique was used. Once it was verified that a positive seat was obtained, a cotton pellet was placed into the screw access, the matrix was filled with bis-acryl (Luxatemp Ultra, Zenith/DMG; Englewood, NJ), seated in the mouth, and allowed to fully set. The access hole was then located, the cotton pellet removed and the provisional was unscrewed and retrieved. Flowable composite (Ivoclar Vivadent) was added to the cervical portion of the provisional to fill the deficient areas and create a smooth transitional surface. It is important to create a facial emergence profile that will allow the tissue to be in harmony with the teeth surrounding it. By under-contouring or flattening the emergence profile, the free gingival margin may provide a thicker collar of tissue that is more incisally positioned. Likewise, by over-contouring the emergence profile, the tissue may be more apically positioned.<sup>3-5</sup> Once proper emergence profile and form was verified, the provisional was positioned, the screw hand tightened, and the access hole filled with a cotton pellet and flexible resin (Systemp.inlay, Ivoclar Vivadent). The patient had a fair amount of white hypocalcification marks present on his teeth; a mixture of white tint (SDI; Bayswater, Victoria, Australia) that was thinned with some clear glaze (Anaxdent; Ardmore, OK) was applied to the provisional to mimic his natural

characterizations (Figs 4-6). It is sometimes necessary to make modifications to the provisional during the three-to-six-month healing phase. It is desirable to keep those alterations closer to the beginning of the healing phase to limit disturbance during final site development.<sup>6</sup>

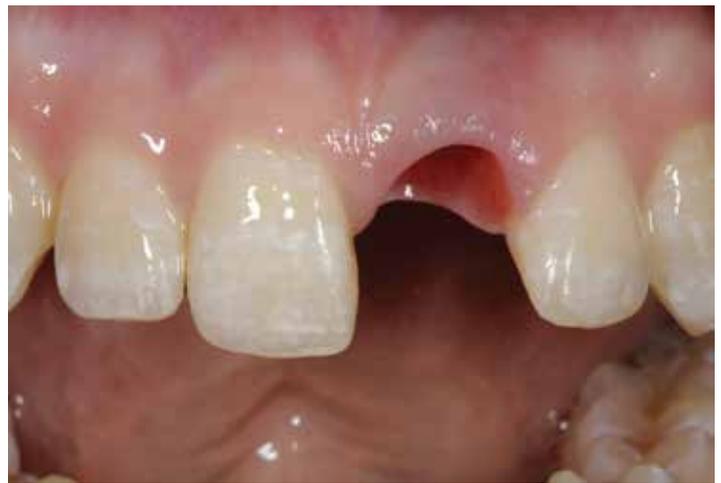
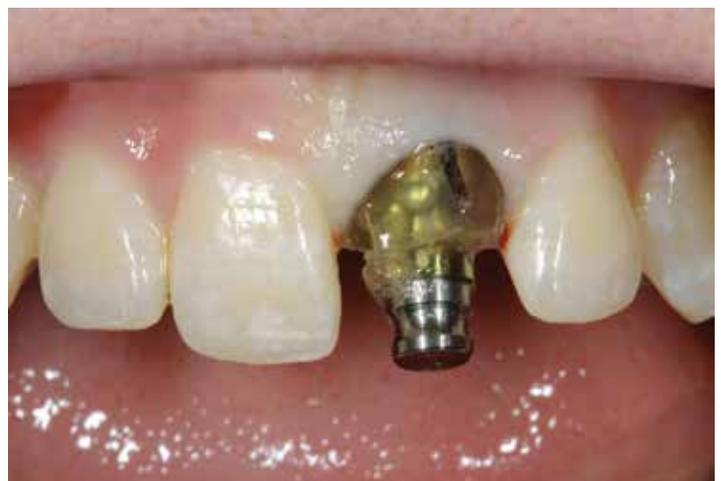
**Figure 8:** Groomed tissue contours after four months.

**Figure 9:** Custom impression coping technique. Note the blanching of tissue collar after only a few minutes of the provisional being out of the mouth.

To accurately predict the peri-implant esthetic outcome, the five diagnostic keys include relative tooth position, form of the periodontium, biotype of the periodontium, tooth shape, and position of the osseous crest.<sup>8</sup> While the determinants of peri-implant esthetics are not dependent upon a provisional restoration, they can serve as a valuable communication tool for both the restorative dentist and the laboratory technician. The ability to see the tissue contours with a provisional before going to a final restoration will allow the restorative team to know the esthetic limitations of what can be achieved.<sup>9,10</sup> In this case the patient, doctor, and technician all approved the esthetics of the provisional and it was decided to proceed with the final restoration after a four-month integration period. A customized impression coping technique was used to capture the cervical tissue contours of the provisional (Figs 8 & 9).<sup>11,12</sup>

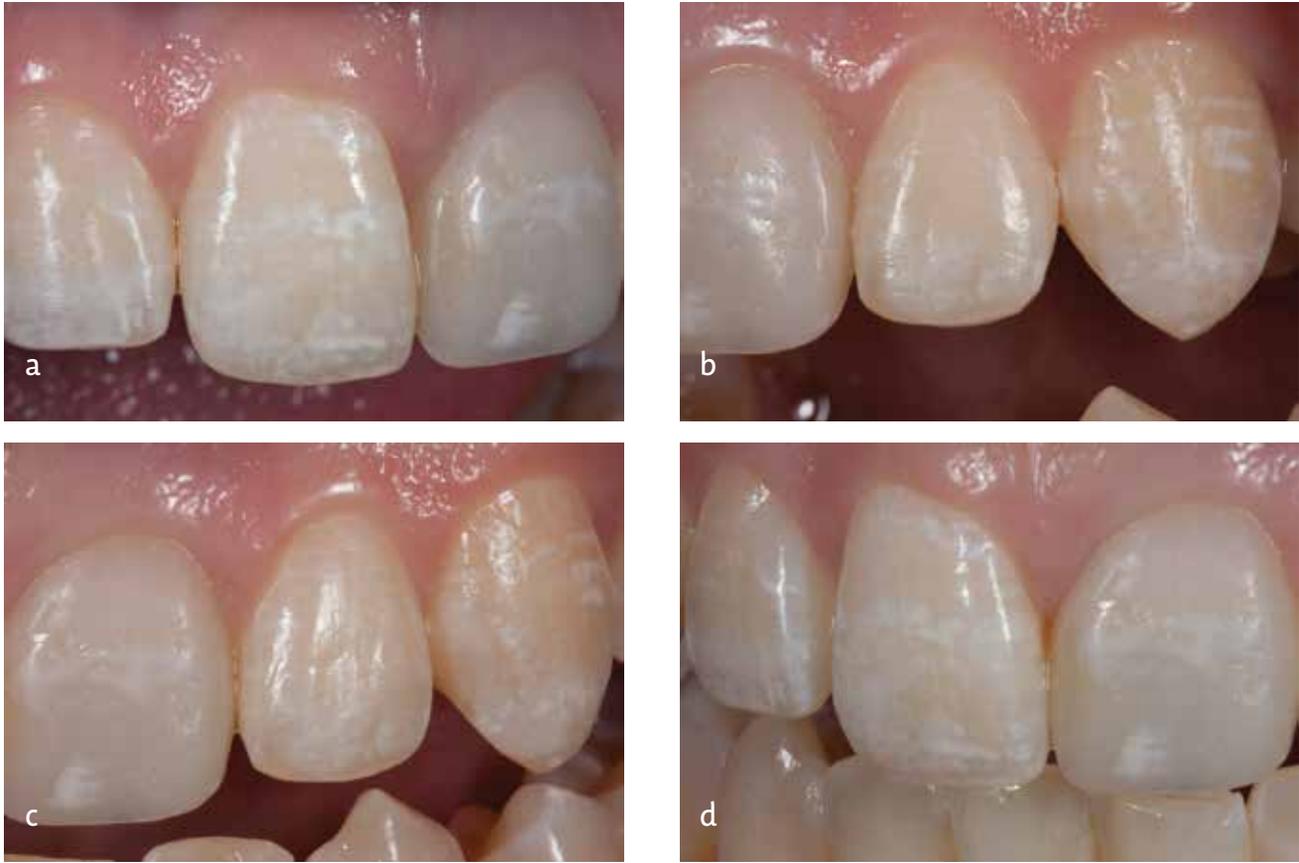
**Figures 10a-10d:** Photographs at different angles to communicate texture, characterizations, and luster.

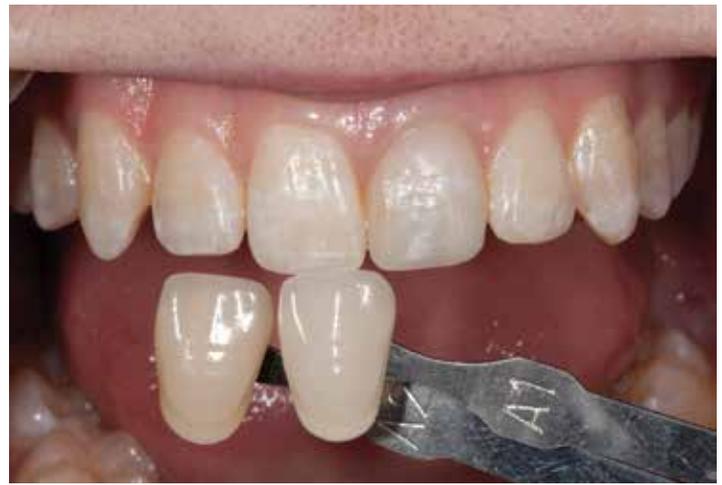
**Figure 11:** Shade communication.

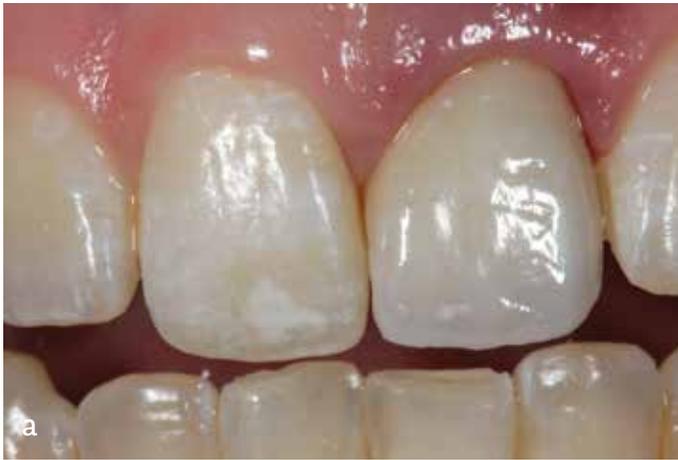
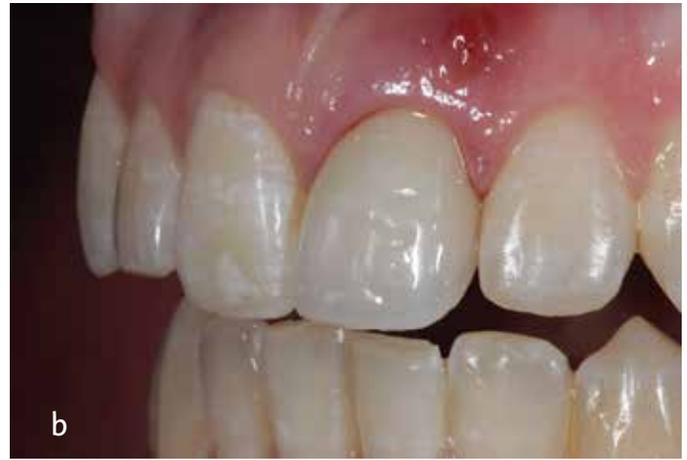
**Figures 12a & 12b:** The first crown displayed tooth width discrepancies and too much translucency. The patient also presented, unaware, with slight screw loosening and peripheral inflammation as a result.

An esthetic hybrid abutment with zirconium luted to a titanium base was fabricated (Core3d Milling Centers; Calgary, Canada) following the design developed by the clinician, and an IPS e.max (Ivoclar Vivadent) core was waxed and pressed from an MO1 ingot.<sup>1</sup> The first crown attempted mimicked the provisional in width and recreated esthetic deficiencies due to the difference in tooth widths of the original #8 and #9. The surface morphology was acceptable, as the working casts were made from impressions that were perfect and communicated surface in great detail.

Translucency is one of the most difficult parameters to evaluate in photographs of teeth. Incisal translucency is relatively simple compared with that of the middle and gingival thirds of teeth. The technician failed to recognize the color density of the natural #8 and applied layering techniques that expressed too much translucency in the body of the crown, thereby lowering its value. Great care should be taken by the dentist to provide verbal confirmations of similarities and differences to and from our known references (shade tabs) in the images sent to the laboratory. The technician should take great care in his or her evaluation of the references in the images to avoid costly corrections and remakes (Figs 12a-13).

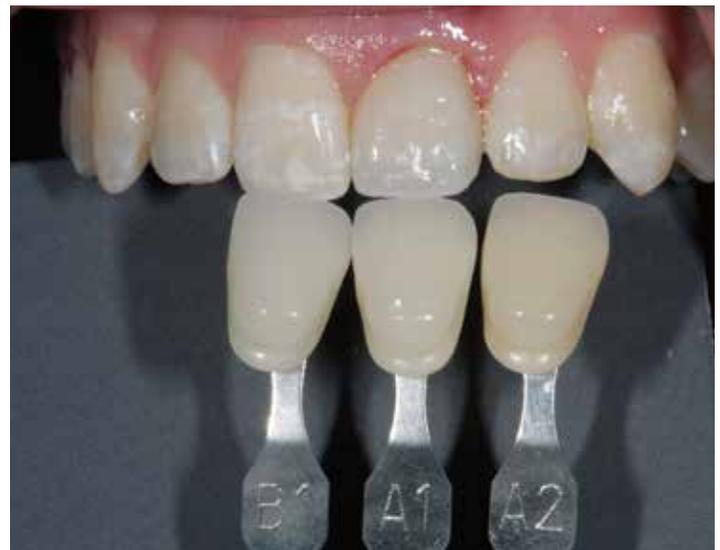
**Figure 13:** First crown try in and shade photographs.

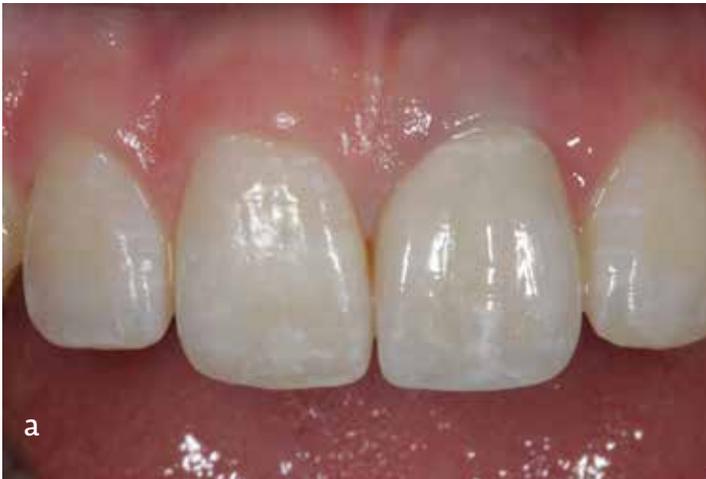
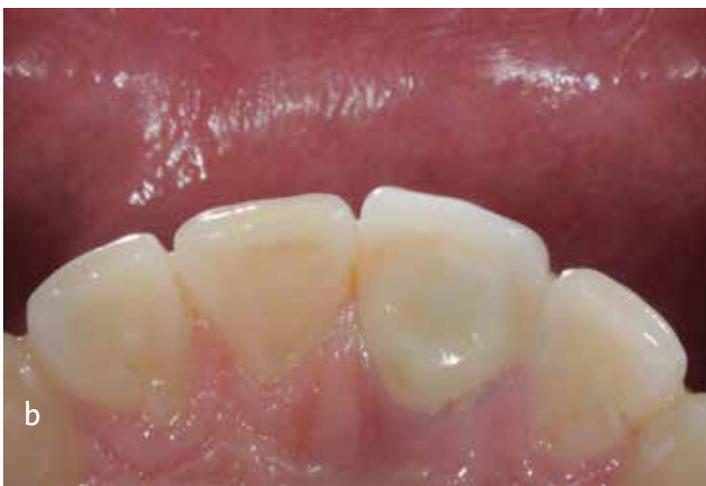
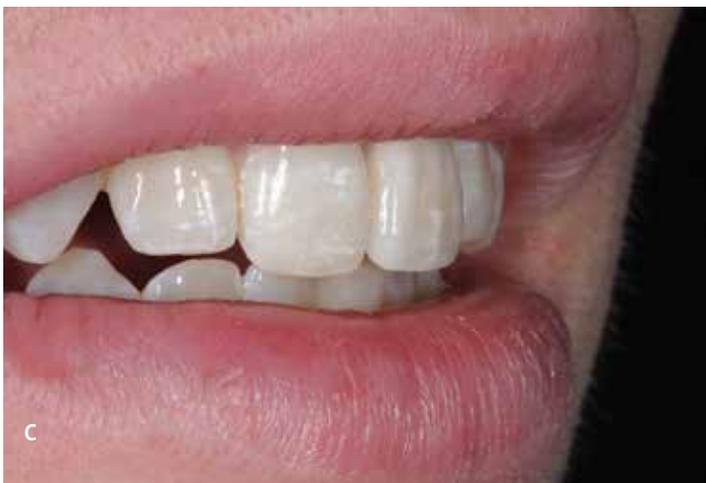
**Figures 14a-14c:** Second crown try in. Color match is excellent but tooth width discrepancy is still evident. Tooth #9 is also more facial to #8 due to occlusion. Note the facial embrasure discrepancy.

The second crown attempted better managed the spatial discrepancy by manipulation of line angles but could not correct the width difference perfectly (Figs 14a-14c). IPS e.max Ceram enamel porcelains were modified with dentin powders and stains to better mimic the density and value of #8.

A minor occlusal problem was discovered that affected the positioning and shaping of the crown. Fabrication of a restoration for #9 with a worn, esthetically compromised incisal edge was not desirable to the patient. Positioning a restoration with an unworn incisal edge in the same arch plane as #8 was not considered a reasonable option. To avoid interfering with the opposing mandibular incisors and match the incisal edge profile of #8 it was necessary to position the incisal edge of the crown labial to that of #8. Other options included adjustment to mandibular teeth on the opposing cast (which would have necessitated further reduction of already worn incisal edges in the patient's mouth). The new crown was sent to the dental office for try in.

Upon evaluation of the crown many things were considered acceptable. The width discrepancy and relative labial position were not. Options were discussed. The technician suggested modification of #8 with composite in order to perfect shade, width, symmetry, and labial positioning relative to the crown made for #9. Minor shade modification was performed in the laboratory prior to returning the crown to the dental office for delivery.

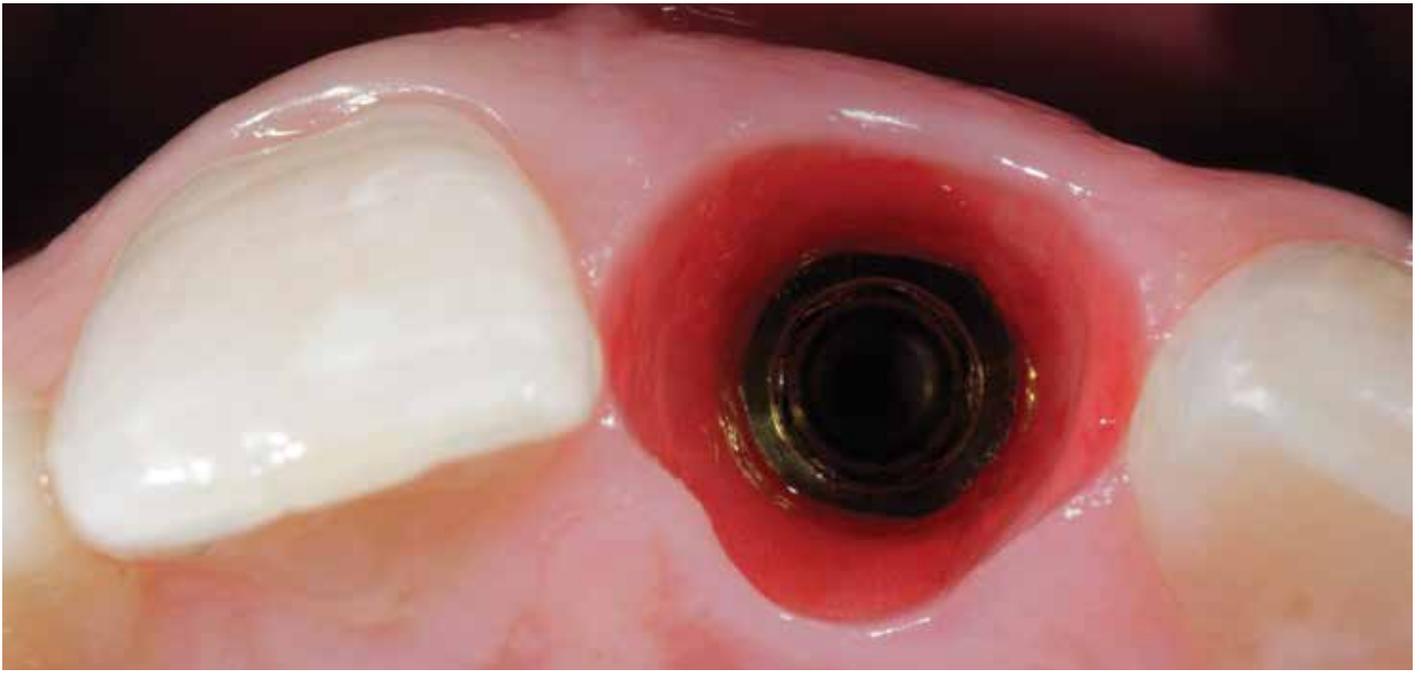
**Figure 15:** Tissue site development.

Once the final implant crown was tried in, evaluated, and determined to be the correct shade and best possible form, the clinician then had to assess the esthetic changes needed to alter #8 in order to replicate #9 as accurately as possible (Figs 15-16b). When trying to choose restorative materials, a clinician often considers not only the cost for the patient and limitations of certain materials, but most importantly, a conservative option that will preserve enamel. Composite (Venus Diamond, Heraeus Kulzer; South Bend, IN) was selected as the material of choice for its chameleon-like ability to match a particular shade and cost savings to the patient. It is both authors' opinion that it is easier to accurately obtain a proper shade match with composite than it is with porcelain. Composite allows multiple and instant shade try ins and color verification. Before commencing the final composite procedure, several shades of composite (A1, CL, AM) were applied to the tooth to visualize and color map a mock-up of the final esthetics. The patient had notable white hypocalcification marks that would need to be replicated using some white tint and layered with a translucent enamel composite shade. Previewing the

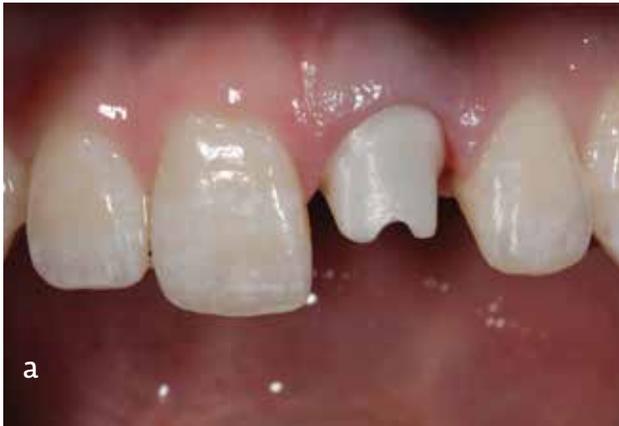
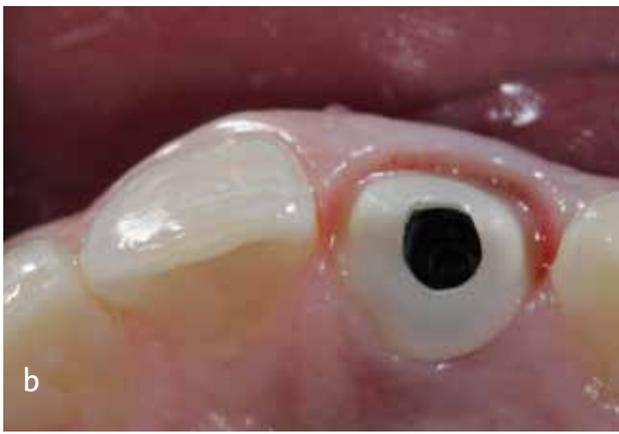
**Figures 16a & 16b:** Zirconium custom abutment.

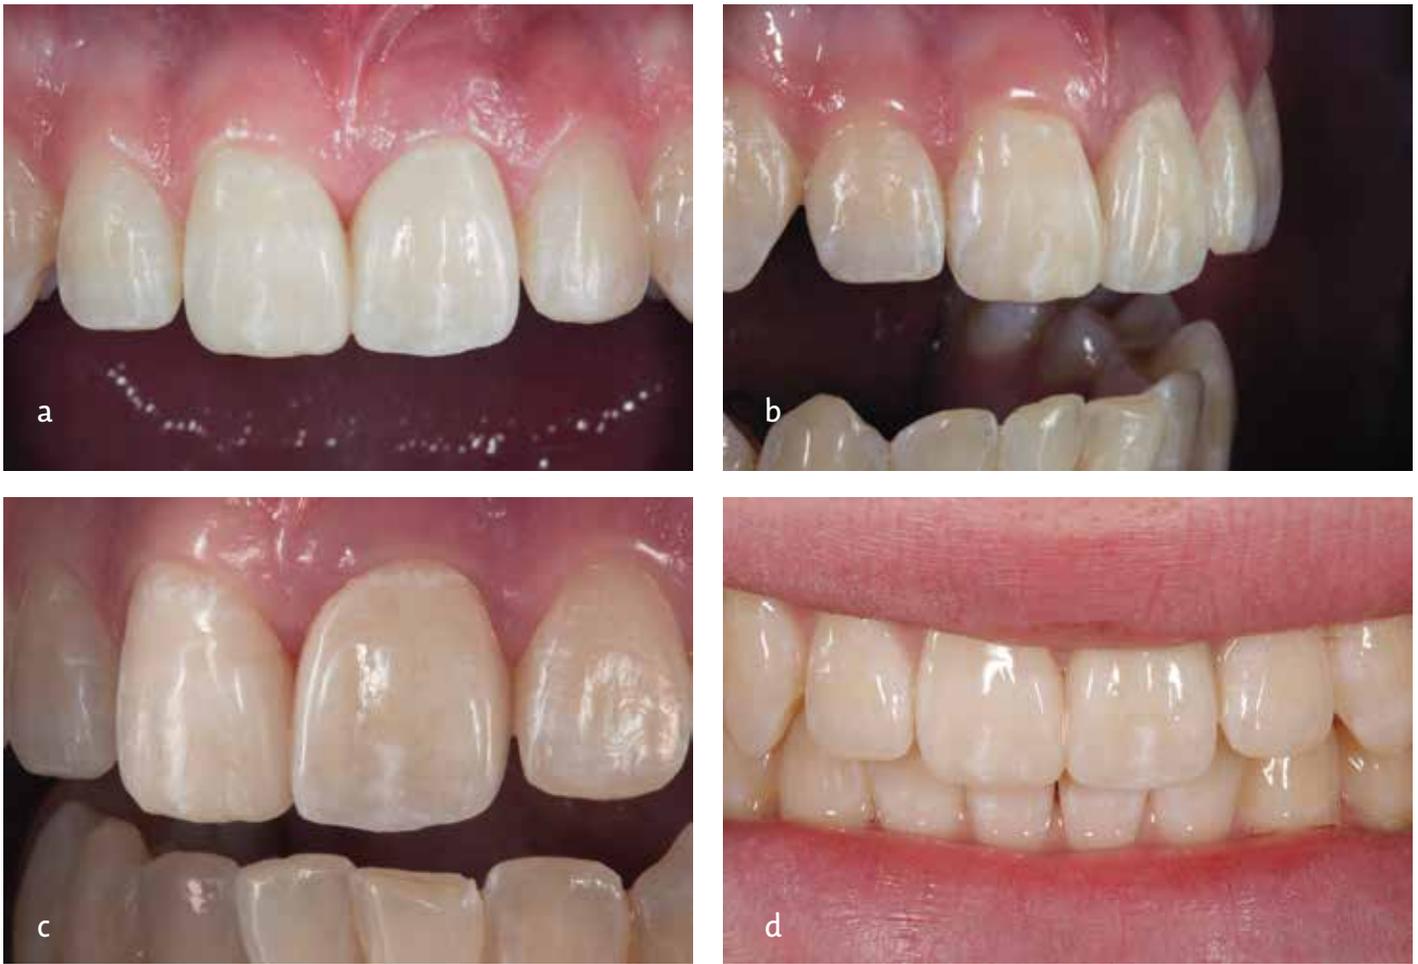
**Figures 17a-17d:** Final implant crown on #9 and direct composite on #8.

While color accuracy was important in the restoration of the composite, it was just as critical to ensure the contours of #8 resembled those on the implant crown of #9. A pencil was used to draw the heights of contour and transitional line angles of the two teeth to more readily assess if proper match had been achieved, as well as evaluation from an occlusal view. The final polish also had to match that of the implant crown and surrounding teeth, which had considerable texture. A fine diamond flame bur (Brasseler USA) was used at low speed and light pressure to create some horizontal lines and a fine disc (Sof-Lex, 3M ESPE; St. Paul, MN) was used to bring the whole restoration to a satin luster. A super-fine polishing cup (Cosmedent; Chicago, IL) was then used to highlight the line angles and create a high shine in those areas (Figs 17a-17d).<sup>13-17</sup>
